Project Catalyst Final Report

Using End of Row Sensors to Manage Tailwater

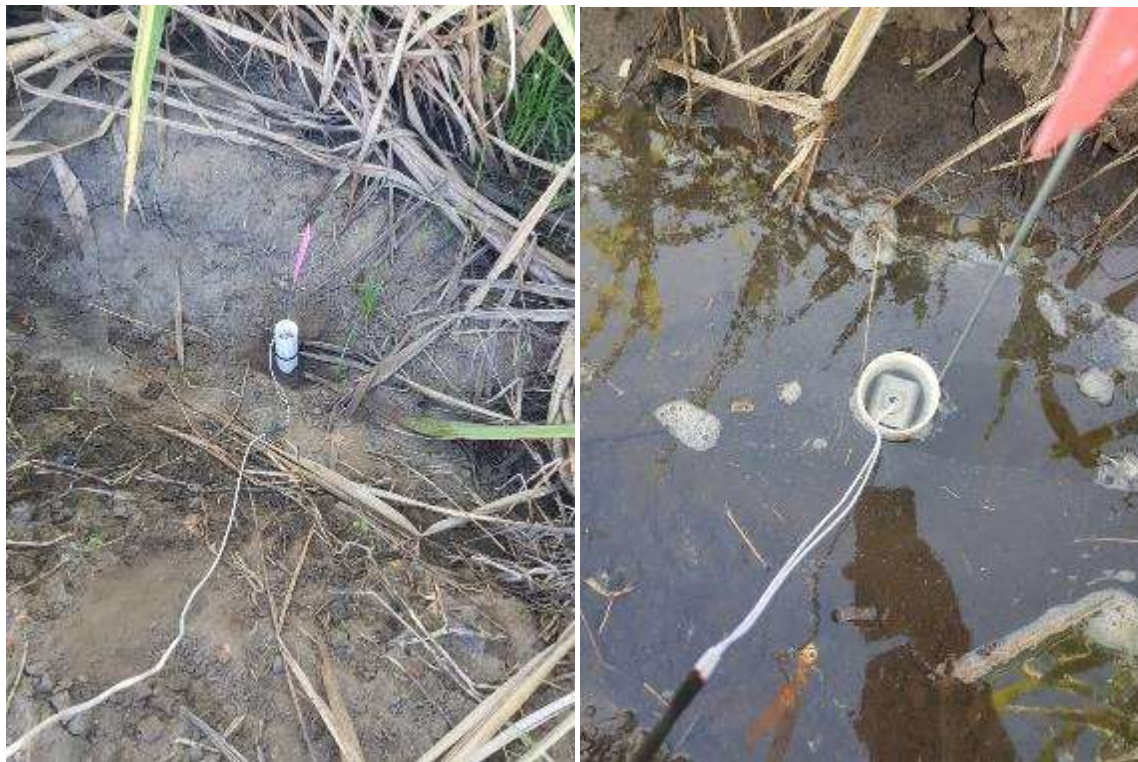
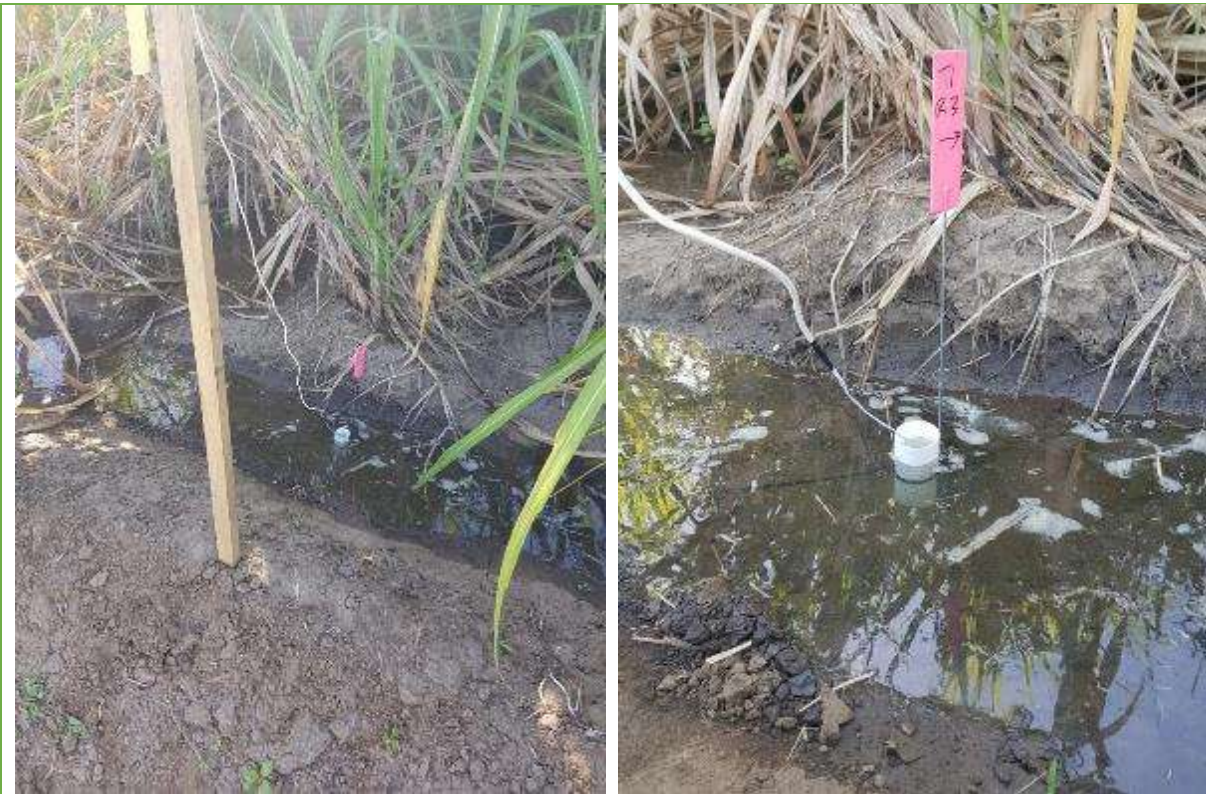
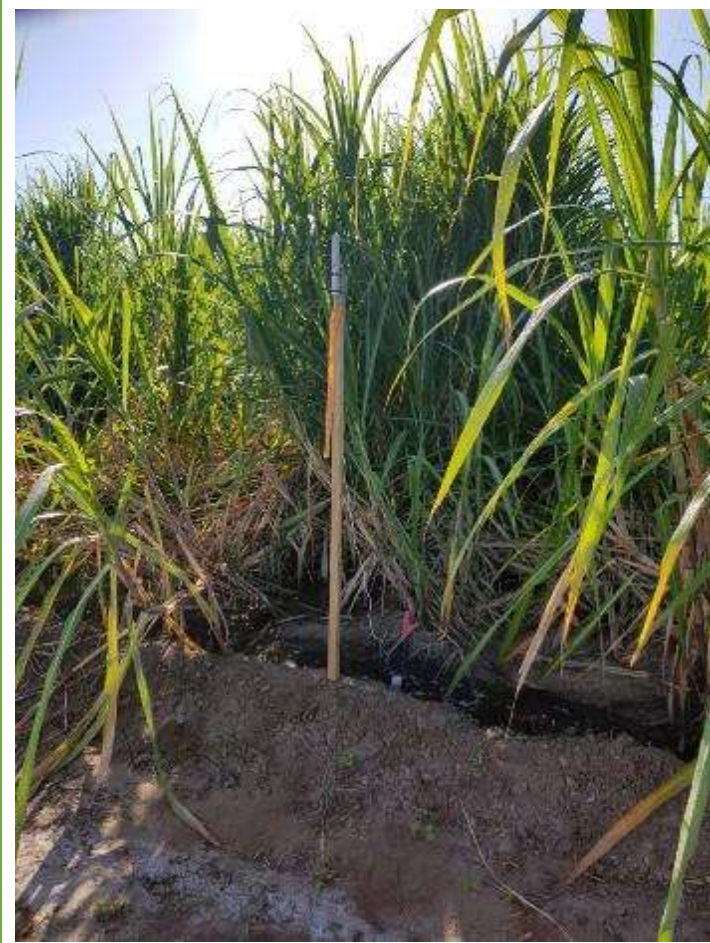
To combat this, the prong sensor was replaced with a float switch. Because the float switch is plastic, the electrolysis issue that was occurring was no longer an issue. It was on this farm that the float switch design was tested for effectiveness, and it was found to be a far more reliable design. There are still some issues – by moving from the electrical option to mechanical, there is a risk that mud or debris will jam or block the float, preventing it from moving up and down and creating/disconnecting the circuit. This has been somewhat mitigated through enclosing the sensor in a section of PVC. This allows water to reach the sensor but prevents large pieces of debris from coming in contact.

Second Design: Float switch system – when the water causes the float to rise, it completes the connection and activates the sensor to read as wet. When there is no water and the float drops, the connection is broken and the sensor reads as dry.
