Project Catalyst Final Report

Using End of Row Sensors to Manage Tailwater

Robert Zandonadi

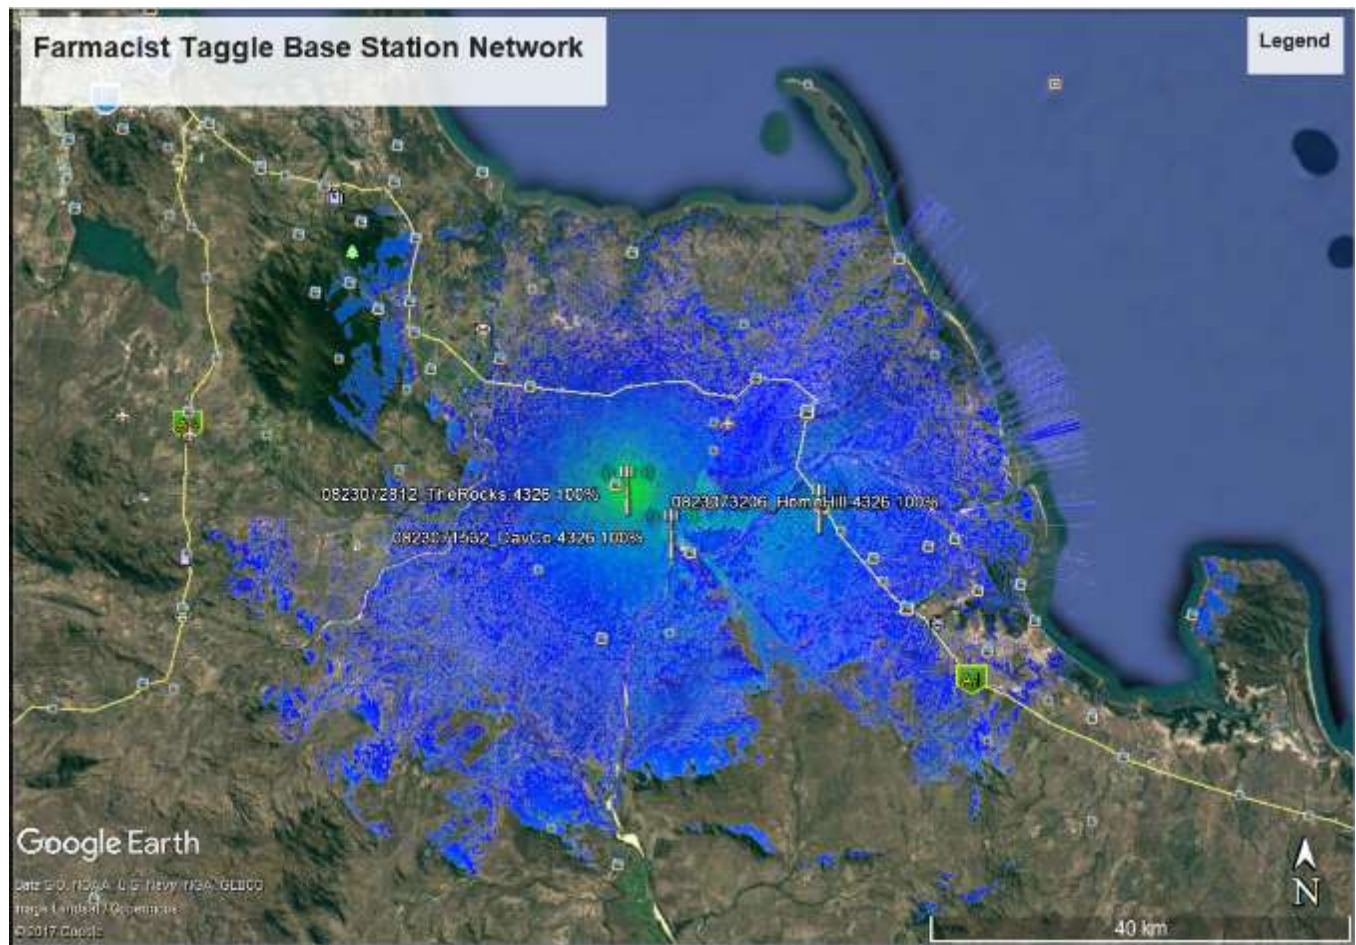
Once the base station network was set up, the coverage is expected to be similar to the image below:

The major issue in this case was the lack of reliable radio signal over this farm. Though the sensor is working, the radio signal issues have prevented the sensors from being used to their full potential.

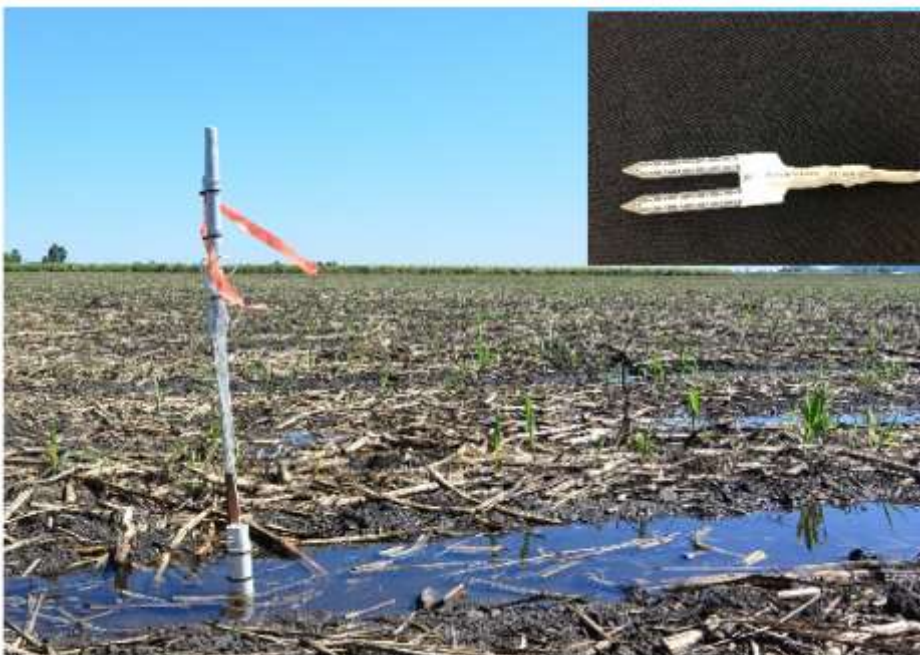
The sensor being used is pictured below:

It is a simple open/close circuit – a complete circuit (in water) reads as “wet” and an incomplete circuit reads as “dry.” The notifications are sent to the Farmacist smart phone app (available for iPhone and Android):

The initial design of the sensors (prong system) was working well; however, due to the way the circuit was designed and the quality of the prong sensors, there was an issue with corrosion. When the sensors were in contact with water, the circuit was running electricity through the prongs, causing electrolysis. This was corroding the plates on the prongs, causing the sensor to send notifications at the wrong time, or not send them at all.

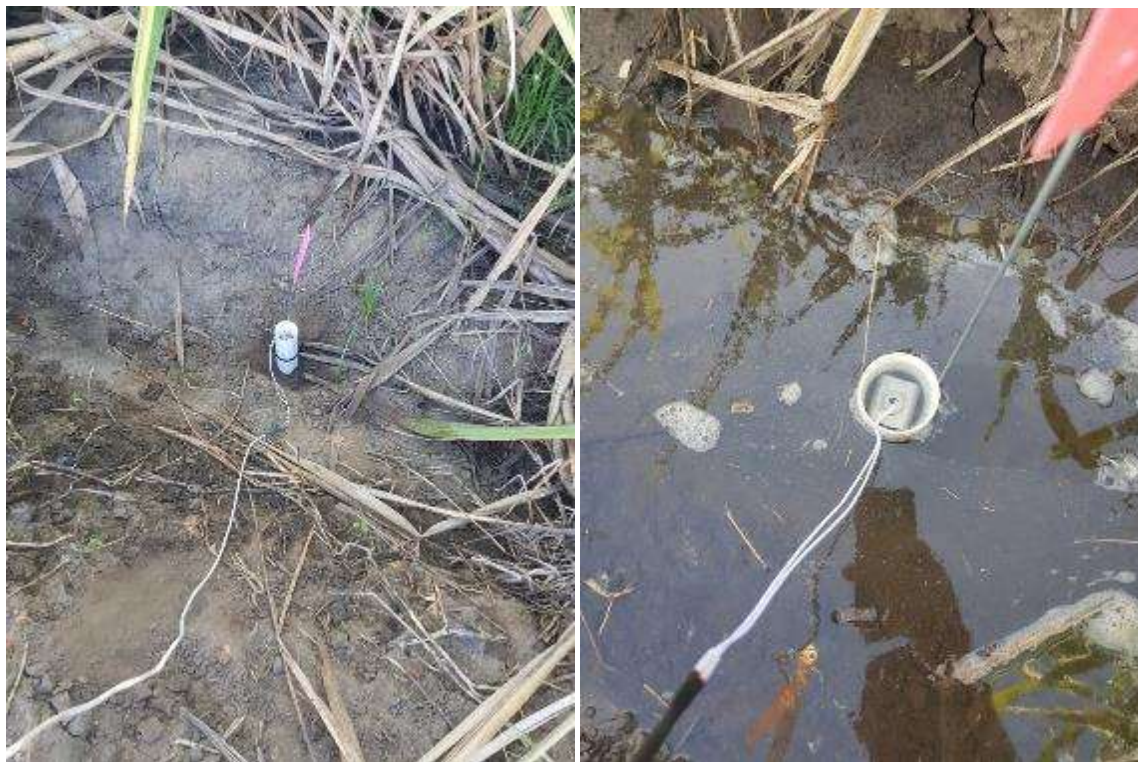
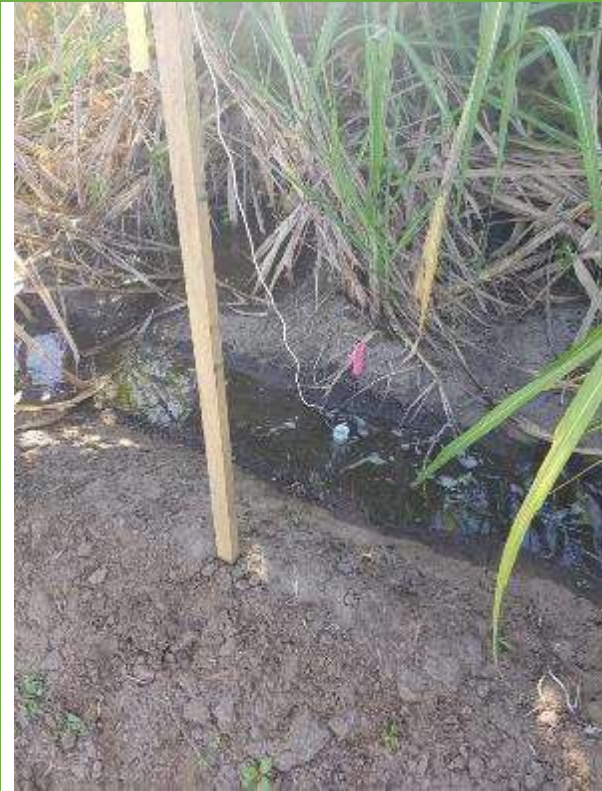
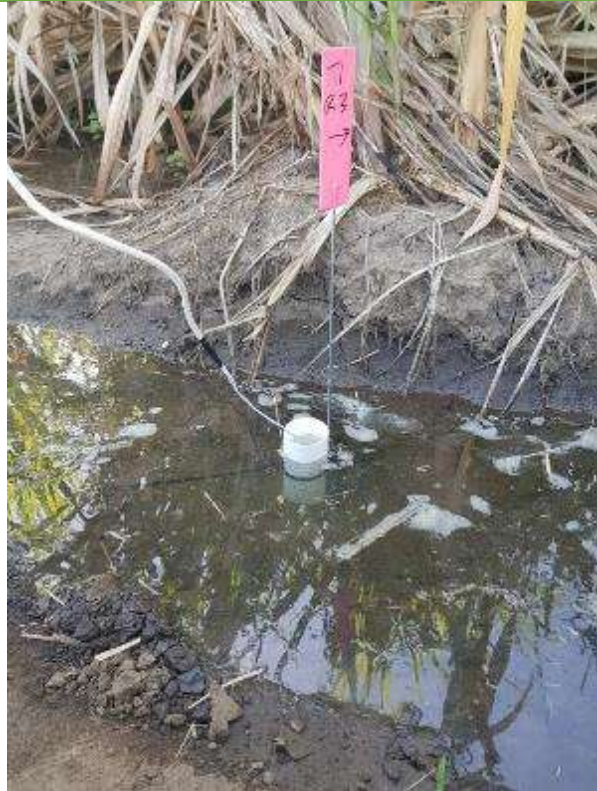
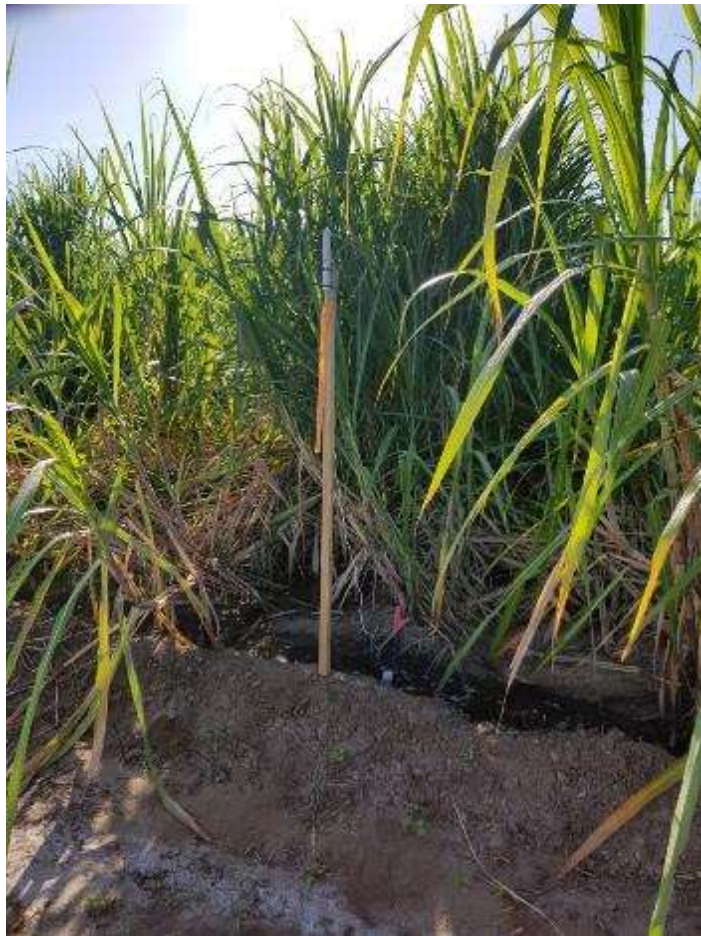
To combat this, the prong sensor was replaced with a float switch. Because the float switch is plastic, the electrolysis issue that was occurring was no longer an issue. It was on this farm that the float switch design was tested for effectiveness, and it was found to be a far more reliable design. There are still some issues – by moving from the electrical option to mechanical, there is a risk that mud or debris will jam or block the float, preventing it from moving up and down and creating/disconnecting the circuit. This has been somewhat mitigated through enclosing the sensor in a section of PVC. This allows water to reach the sensor but prevents large pieces of debris from coming in contact.

Second Design: Float switch system – when the water causes the float to rise, it completes the connection and activates the sensor to read as wet. When there is no water and the float drops, the connection is broken and the sensor reads as dry.
